Hidden Lake Estates Homeowners Association Membership Meeting

SUBJECT: Site Observation of Bull Frog Reservoir; ID#01296; File#B-23; Cert.#35208

DATE: 8-16-2021

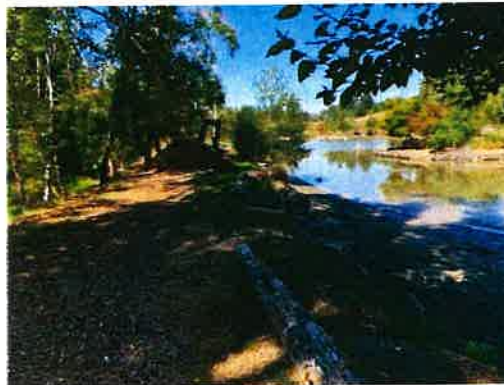
Looking at Drained Water surface; Excavated pit on 'Retaining Dike'

Stuntzner observed an approximately 8'±x8'±x10'± (LxWxH) exploratory pit at the centerline of the 'Retaining Dike' in order to try and determine the cause of a 3'± depression at this location. To Stuntzner's knowledge, the original depression on the 'Retaining Dike' is likely created by decomposing organics within the dam embankment. The encountered organics will be removed and the exploratory pit will be backfilled with suitable clay material. The extent of organics in the dam embankment are not known. Stuntzner conservatively assumes this is not an isolated event. There should not be organics within the dam embankment.

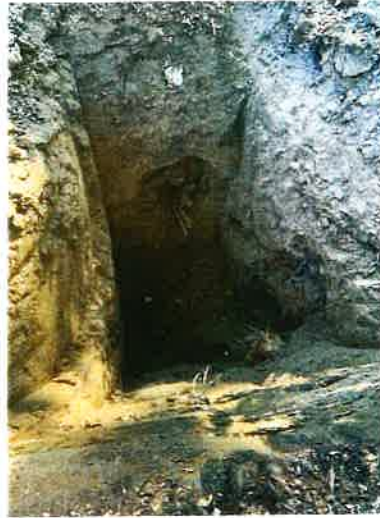
There is a buried stump at the bottom southern end of the pit. There is also a buried tree that extends beyond the extents of the exploratory pit. The buried organics will be removed prior to backfilling

Top View of Exploratory Pit on 'Retaining Dike'

the exploratory pit with suitable backfill material. There are several living and dead Alder trees on the outside embankment at this area that will also be removed. See the pictures below for site observations.

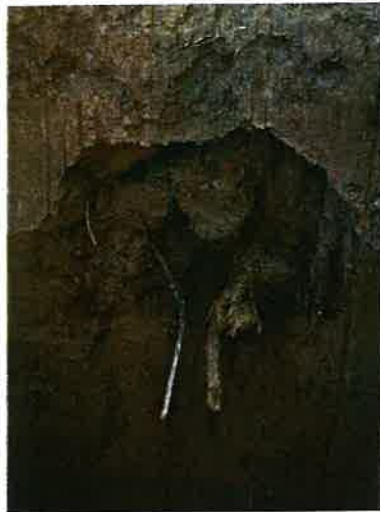
Buried Tree 6'± Below Ground Surface on 'Retaining Dike'

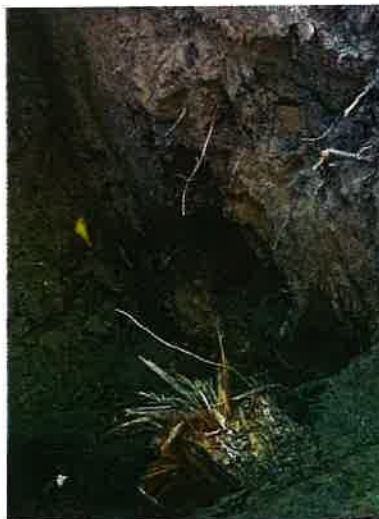
Stump and Tree at Bottom of Exploratory Pit on 'Retaining Dike'

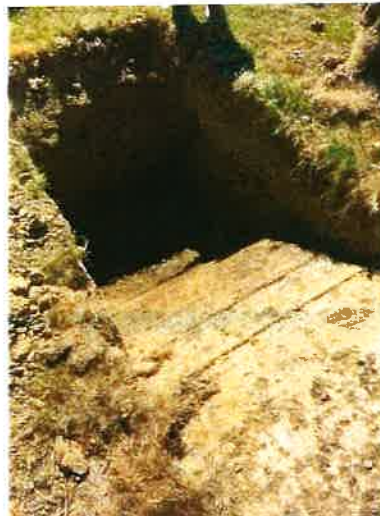
Borrow Pit #1 on Tax Map

Stuntzner recommends that the owner contact Nick Blundon if backfill material from Borrow Pit #2 will be used within the dam embankment. Material from Borrow Pit #2 has not yet be observed by Stuntzner and it is currently not verified that there is suitable native clay material free of organics and

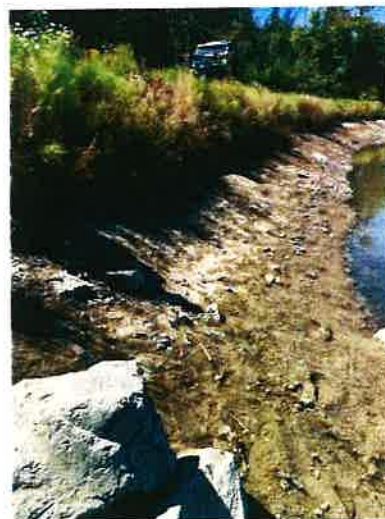
Southwest 'Retaining Dike' at Location of Proposed Rip Rap

The owners are also proposing to install some erosion control measures to help prevent erosion from wave action. The owners are proposing to install ODOT Class 50 Rip Rap near normal pool elevation to help prevent erosion from wave action. Wave heights are not expected to reach higher than 1± foot. The contractor will likely excavate a bench for the rip rap layer, then install non-woven geotextile fabric (retains fine sediment particles from eroding away by wave action between rocks), then install the ODOT Class 50 Rip Rap approximately 1' minimum in depth. Refer to ODOT specifications at the end of this report.
