Hidden Lake Estates Homeowners Association Membership Meeting

SUBJECT: Site Observation of Bull Frog Reservoir; ID#01296; File#B-23; Cert.#35208

DATE: 8-16-2021

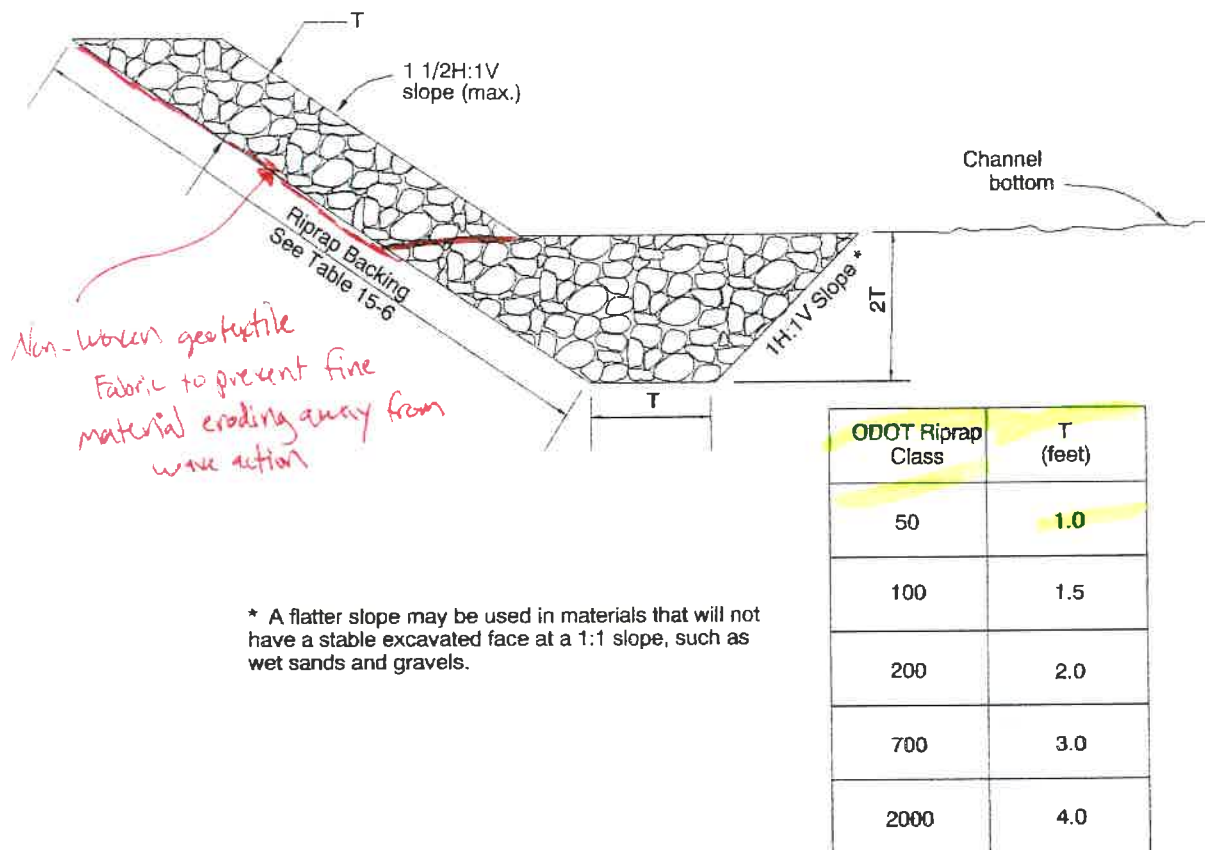
Figure 15-4 Standard Riprap Section

Method 1: Construct a standard toe trench with the dimensions shown on Figure 15-4. The bottom of the toe trench is at or below the estimated maximum scour depth. In this case the maximum scour depth should not be greater than 2T, where T is the riprap blanket thickness. This is the preferred design for embankment protection, and it is also recommended for bridge abutments. As a minimum, the standard toe trench should be used for toe protection.
